# Home Inspection Report

Thor Home Inspection Service, Inc.  
925 N. Savannah Drive  
Sioux Falls, SD 57103  
605-335-6889

May 24, 2006

RE: 541654 Apple Lane  
Sioux Falls, SD

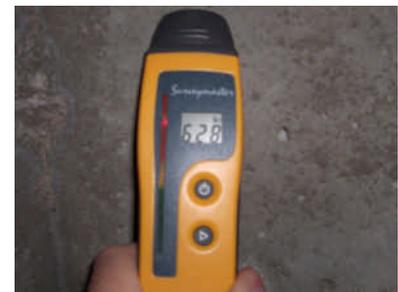
High moisture content in the exterior walls can lead to mildew and wood rot in high concentrations. The moisture content noted is high enough to cause either or both. Refer to perimeter grading on South side.

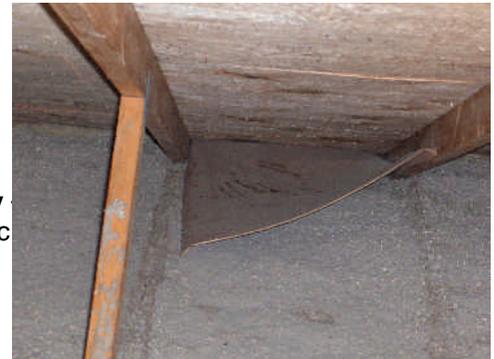
The soffit vent screens are plugged with debris & should be cleaned or replaced for better air flow. The cardboard airway panels fastened between the trusses have collapsed into the roof sheathing greatly lowering or stopping air flow. **Action Necessary**

There is a moisture problem in the attic cavity that requires immediate repairs.

This is evidenced by staining in the insulation from condensation dripping.

Also, it appears that the hallway bathroom exhaust fan may be vented into the attic - see Bathroom section.

Solution: 1. The airways can be opened in several different ways; insert a short piece of 2x4 into the center of the airway & turn it to push the cardboard back down. 2. Slide a pre-formed manufactured plastic or foam airway through the airway. 3. Rake the insulation back away from the cardboard, remove cardboard & replace with manufactured airway spacers.

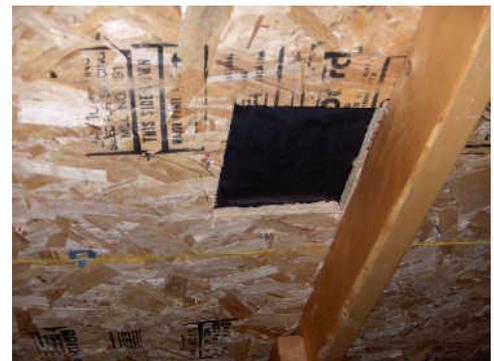
The picture displays a roof vent opening in the attic that was not cut through the shingles & felt paper. Recommend installing additional vent here when shingles are replaced in 1 - 3 years.

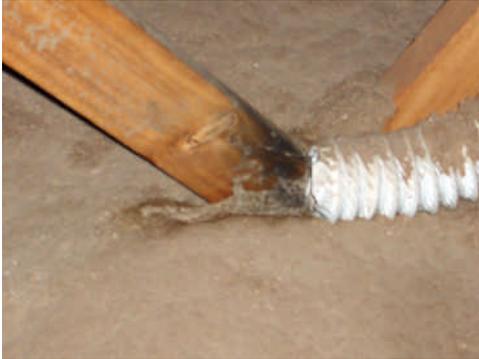
<b>Location:</b>	Upstairs Hall.
<b>Entry Door:</b>	Satisfactory - The entry door to the bathroom is as I expected, and it is functional.
<b>Walls:</b>	Satisfactory - The walls in this bathroom are satisfactory.
<b>Ceiling:</b>	Moisture Damage - The damage to the ceiling in this bathroom appears to be caused from moisture coming from the attic. See Fan below.
<b>Floor:</b>	Satisfactory - The flooring in this bathroom is satisfactory.
<b>Lighting:</b>	Satisfactory - The ceiling light and fixture in this bathroom are in satisfactory condition.
<b>Ventilation Fans:</b>	<p>The ventilation fan vents into the attic space. This introduces moisture into the attic that must be removed from the attic. It would be better to vent the bathroom to the outside rather than the attic.</p>
